Photoelectricity Hybrid Connector

SC光电复合连接器

● PHC-SC-1F2W

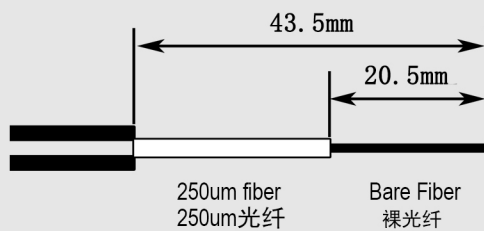
【7】Cutting length 光纤切割尺寸

Picture shown only for reference.
仅数值参考。

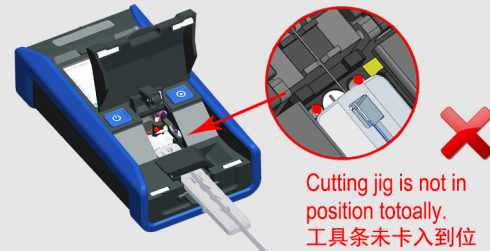
【9】Prepare the endface melter 熔端准备

Put the cutting jig with cable on the bracket of melter, close the melter cover.
将切割好的光纤(连同工具条)放入熔端机定位托座内, 合上翻盖。

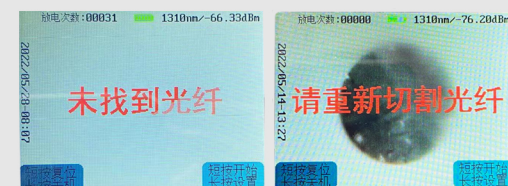
【10.2】Error message 告警说明

NO Fiber: error message generated when fiber prepared wrong or cutting jig is not installed properly.
未找到光纤: 光纤制备异常或工具条没有正确安装

Replace Fiber: error message generated when fiber cutting quality poor or high arc power.
请重新切割光纤: 光纤切割质量差或放电功率偏大

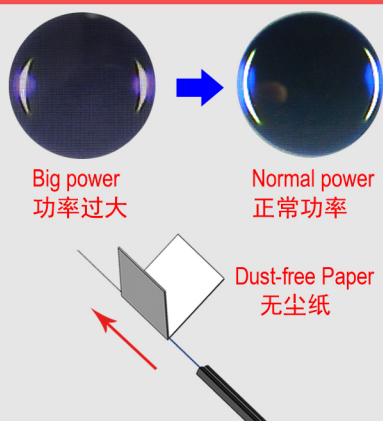
1、Difficult to insert fiber 穿纤不畅

- ① Power is too big: dirty thing on the tip of the electrode caused big power, clean the electrode and empty discharge more than ten times. If still not work, decrease the discharging power according to <Fiber endface melter manual>.
功率过大导致穿纤不通：放电针针尖上有异物引起放电功率变大，清洁放电针并空放电10次以上再使用；如没有改善，则参照《熔端机说明手册》将功率调小。

- ② Dirty fiber: clean fiber carefully with dust-free paper dipped in alcohol.
光纤清洁不干净导致穿纤不通：用无尘纸蘸酒精清洁光纤。

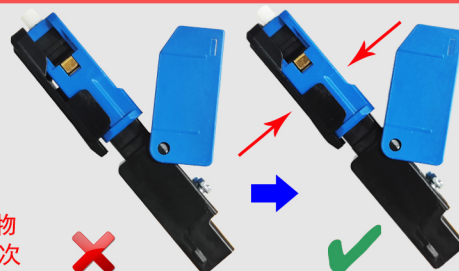
- ③ The opener is loose: Press the opener hard, make sure that the opener is in position totally.
钥匙弹出导致穿纤不通：按照如图所示正确方法压住钥匙穿纤，确保钥匙处于闭合状态。

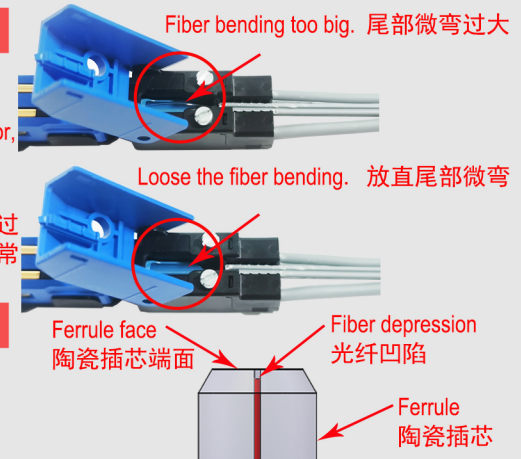
2、High loss cause internet cannot work 光衰大无法开通

If use the same batch of fiber optic cable, no matter how to assemble, loss is still high, and the loss in 1550nm wavelength is much higher than in 1310nm, it means the batch of cable's quality does not meet the quality standard or the fiber bending in the connector tail is too large. Reduce the bending of the optical fiber at the tail of the connector, then the loss is back to normal. (If use qualified cable, no need to do this process)

若同一批次光缆，无论怎么组装光衰始终比较大，而且1550nm波段的光衰明显大于1310nm波段的光衰，则说明该批光缆质量达不到正常皮线光缆的标准或者是尾部的弯曲过大，则可以通过减小甚至放直光纤在连接器尾部形成的弯曲，则可以实现光衰的正常。（正常光缆无需如此，正常组装即可）
